WHAT REALLY MATTERS IN A HOME INSPECTION

Saturday, February 13, 2021

Inspection Site

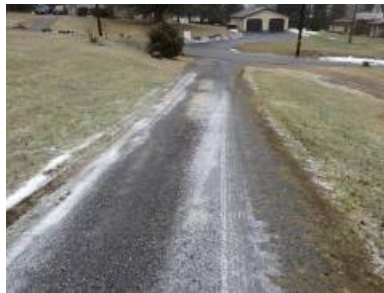
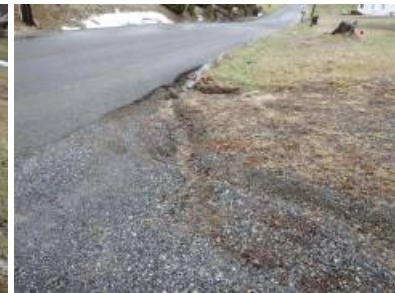
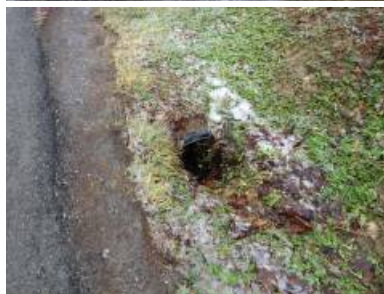
Defects/ Concerns Noted: Poor drainage noted end of the driveway

Recommend keeping the drain pipe clear and free of debris to provide good drainage.

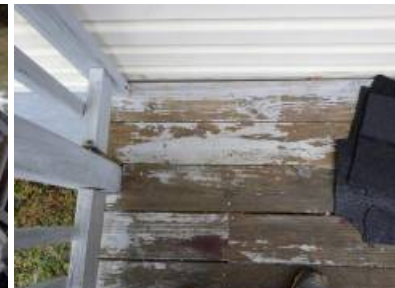
Deck planking (the walking surface) had moderate wear or deterioration visible. Routine maintenance should improve its lifespan.

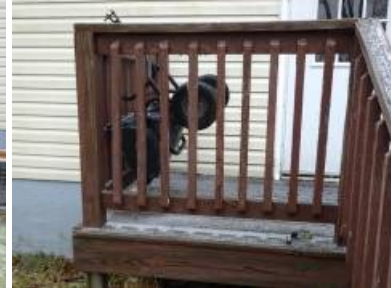
Recommend having a continuous gripped handrail be installed for safety.

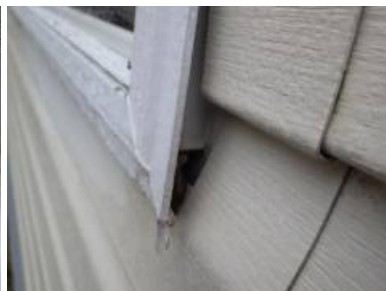
J-block / mounting block was not installed on one or more exterior fixture(s) penetrations. This can lead to moisture intrusion if not properly sealed and maintained.

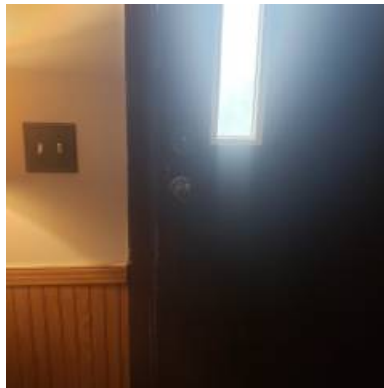
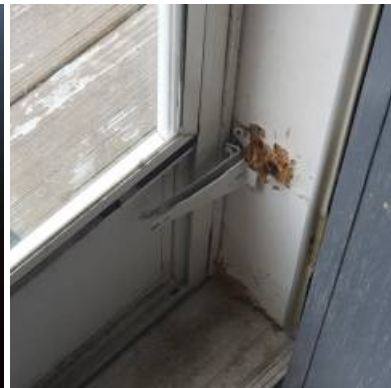
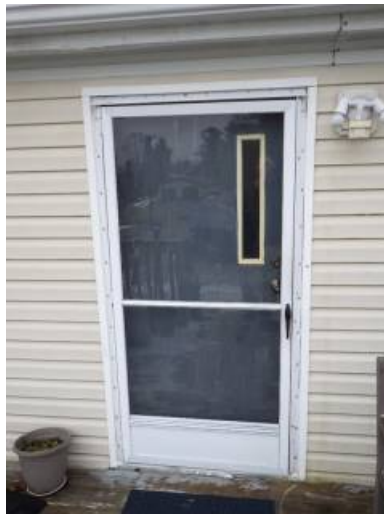
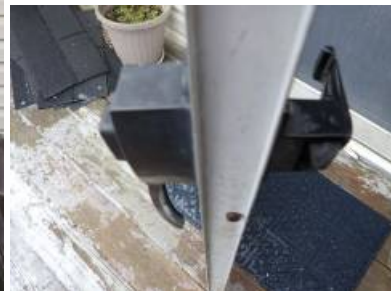
The doorknob assembly needs adjustment / repairs / replaced..

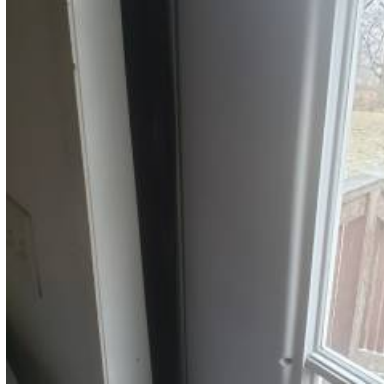
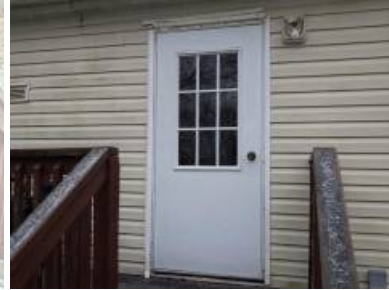
Threshold is loose and needs tightening / Repairs.

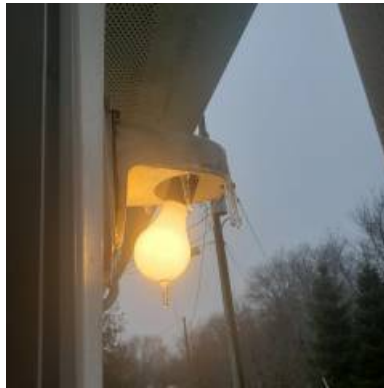
Missing light cover noted- Recommend replacing cover.

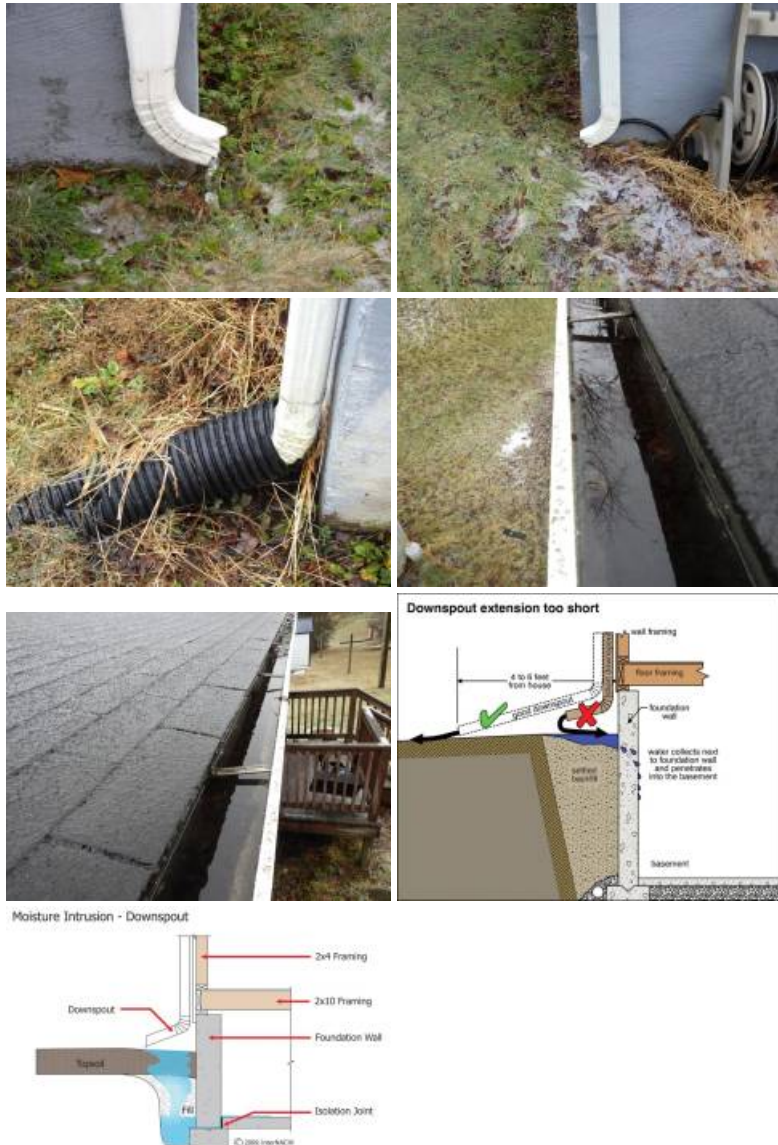
☐ ☐ ☒ ☐ Damage/Defects,
 Rear Gutter is sloped improperly and holding water- recommend correcting
 Damaged downspouts noted
 Extend downspouts to route rainwater away from the building.
 Gutters are discharging water near the foundation.

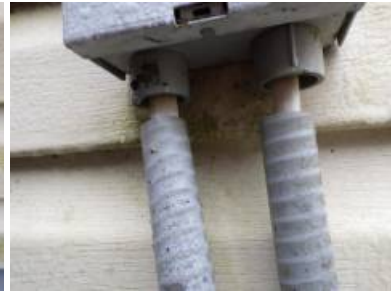
Conduit was noted to be broken/ detached from the breaker box and has wire exposed. - Recommend corrections as needed.

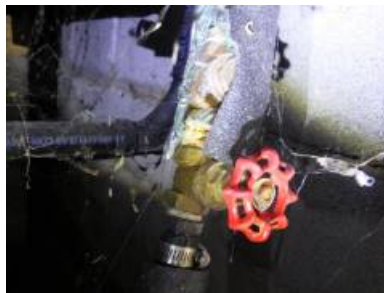
OK	NI	MM	RR	
<input checked="" type="checkbox"/>	<input type="checkbox"/>	<input type="checkbox"/>	<input type="checkbox"/>	Main Shutoff Valve, was not tested.
<input type="checkbox"/>	<input type="checkbox"/>	<input type="checkbox"/>	<input checked="" type="checkbox"/>	Active leak visible at the main water supply shut-off at the time of the inspection- Recommend repairs as necessary by a qualified professional contractor.

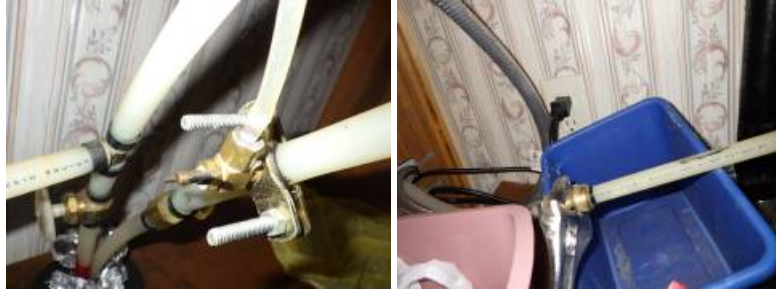
Pans and other indications of past leakage noted at the water supply for the dishwasher , while not leaking at the time of the inspection recommend monitoring in the future for leakage and repairs as necessary.

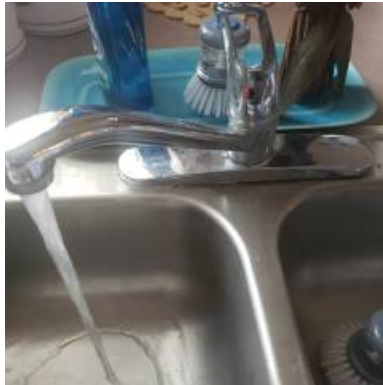
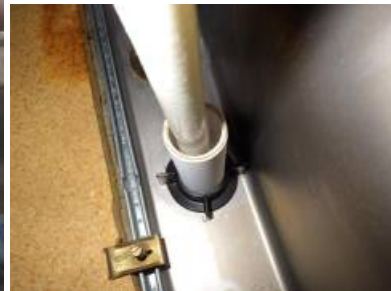
<i>Sink Fixture:</i>	<input type="checkbox"/>	<input type="checkbox"/>	<input type="checkbox"/>	<input checked="" type="checkbox"/>	The spray wand was operated and functional at the time of the inspection Spray wand Fixture leaks and should be repaired to prevent damage.
----------------------	--------------------------	--------------------------	--------------------------	-------------------------------------	--

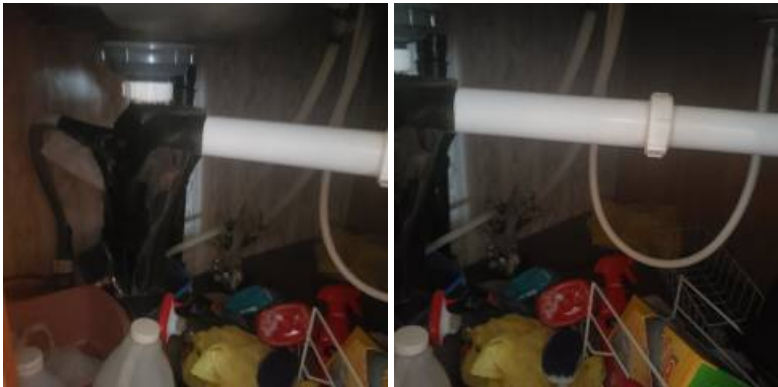
<i>Sink Drain:</i>	<input type="checkbox"/>	<input type="checkbox"/>	<input checked="" type="checkbox"/>	<input type="checkbox"/>	Unconventional plumbing repairs noted. Improper plumbing connection noted. Recommend monitoring in the future and repairs as necessary.
--------------------	--------------------------	--------------------------	-------------------------------------	--------------------------	---

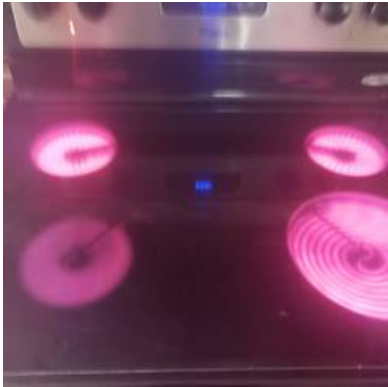
OK	NI	MM	RR	
<input type="checkbox"/>	<input type="checkbox"/>	<input checked="" type="checkbox"/>	<input type="checkbox"/>	Water damage in cabinet noted.
<input checked="" type="checkbox"/>	<input type="checkbox"/>	<input type="checkbox"/>	<input type="checkbox"/>	Electric, Appears serviceable.

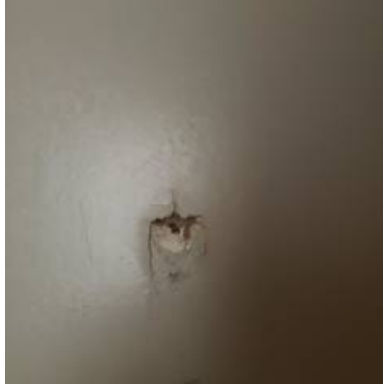
☐ ☐ ☒ ☐ Damage noted.

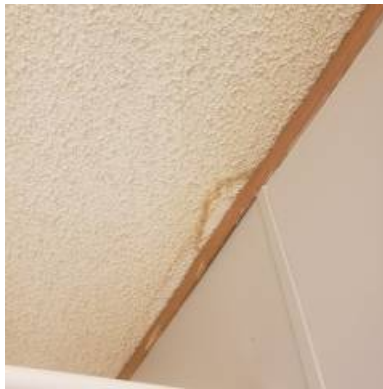
☐ ☐ ☒ ☐ Previous Leak - There are signs of a previous water leak in the ceiling in this room. It does not appear to be an active leak.

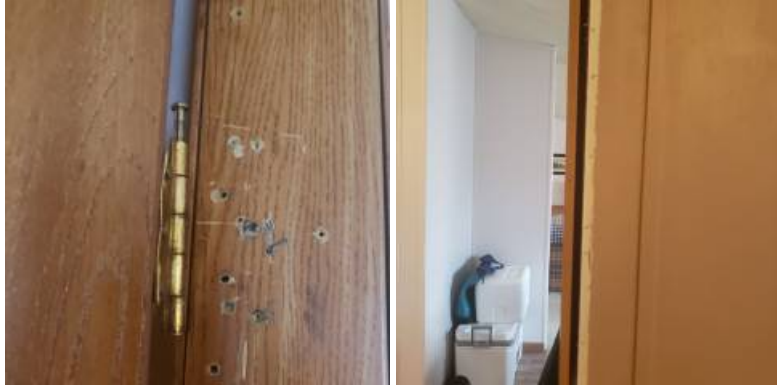
☒ ☐ ☐ ☐ Missing trim noted around door frame.

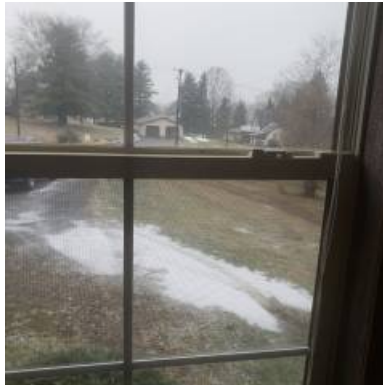
☐ ☐ ☒ ☐ At least one window or associated hardware in this room needs repair. The spring or slide that holds the window in the up position is nonfunctional. It needs to be replaced.

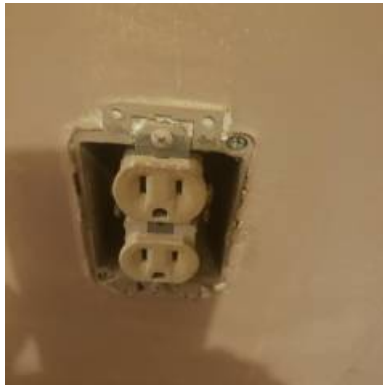
Missing outlet cover noted.

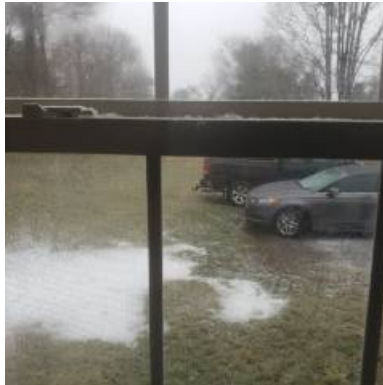
☐ ☐ ☒ ☐ At least one window or associated hardware in this room needs repair. The spring or slide that holds the window in the up position is nonfunctional. It needs to be replaced.

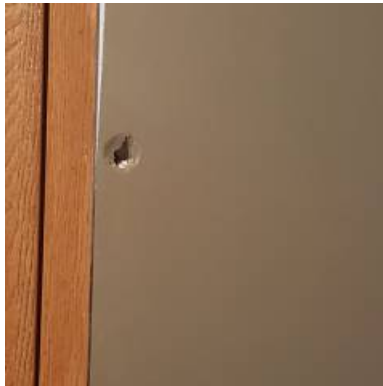
☐ ☐ ☒ ☐ Damage noted.

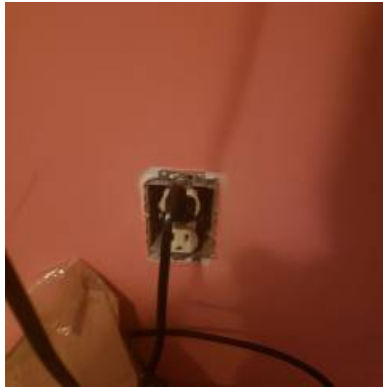
OK	NI	MM	RR	
<input checked="" type="checkbox"/>	<input type="checkbox"/>	<input type="checkbox"/>	<input type="checkbox"/>	Appears serviceable.
<input type="checkbox"/>	<input type="checkbox"/>	<input checked="" type="checkbox"/>	<input type="checkbox"/>	Missing outlet cover noted.
