WHAT REALLY MATTERS IN A HOME INSPECTION

Saturday, February 13, 2021

Inspection Site

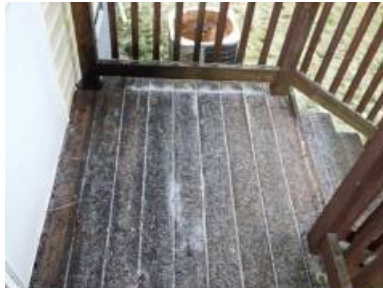
Rear Deck:

- ☒ ☐ ☐ ☐ Deck Type: Wooden
 Deck planking (the walking surface) had moderate wear or deterioration visible. Routine maintenance should improve its lifespan.

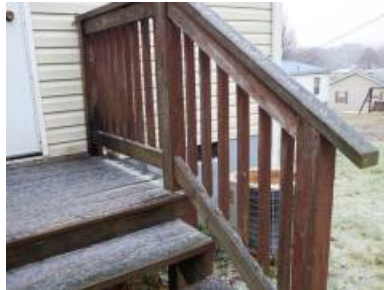
Recommend regular maintenance to deck surface.

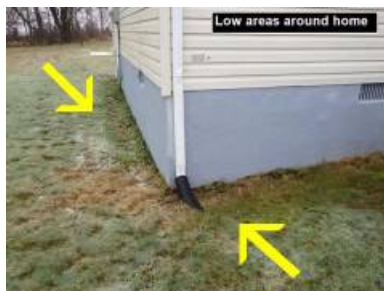
Any flat or low areas around the home should be backfilled and sloped away (min. 1/2 inch per foot for 10 feet) from the foundation to prevent potential moisture intrusion

Extend downspouts to divert water away from the house foundation.

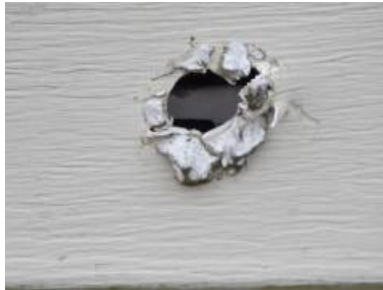
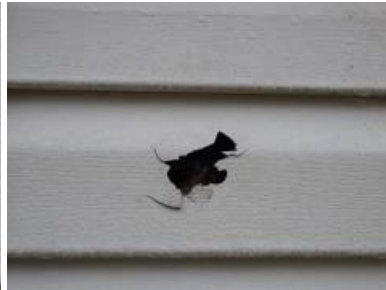
Maintenance: Caulk around the A/C lines and any holes, gaps, or penetrations points to reduce the risk of moisture and pest intrusion.

All surfaces of the building envelope should be inspected and maintained on a continual basis.

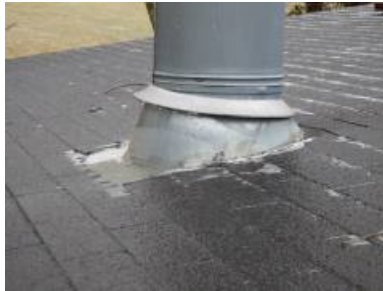
Flashing:

☐ ☐ ☒ ☐ Recommend yearly maintenance / inspection to ensure weatherability.

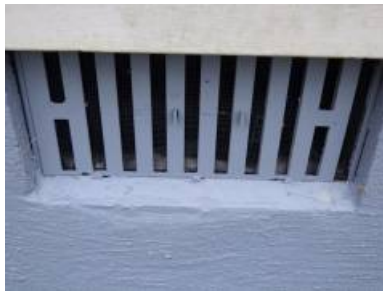
Moisture: OK ☐ NI ☐ MM ☒ RR ☐ Yes - Higher than normal moisture levels were noted on the exposed areas of the interior crawlspace walls, and attention is needed to determine the cause and best cure.
The best defense against water seepage is good drainage of soils near the foundation wall.

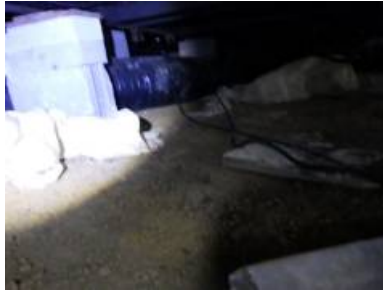
In Unfinished Areas: OK ☐ NI ☐ MM ☒ RR ☐ Insulation is installed at under floor areas
There is a vapor barrier installed. Plastic vapor barrier is no longer effective (cut, not covering ground, improper/ missing tape) and is need of improvement.

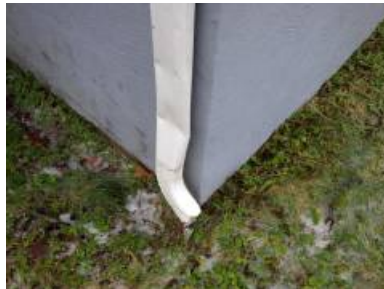
Condition:

Rear Gutter is sloped improperly and holding water- recommend correcting

Damaged downspouts noted

☐ ☐ ☒ ☐ Damage/Defects,
 Rear Gutter is sloped improperly and holding water- recommend correcting
 Damaged downspouts noted
 Extend downspouts to route rainwater away from the building.
 Gutters are discharging water near the foundation.

Extend downspouts to route rainwater away from the building. Gutters are discharging water near the foundation.

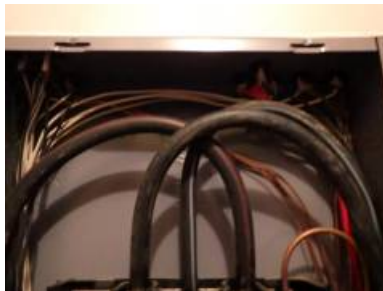
Anti-oxidant paste not observed - Recommended.

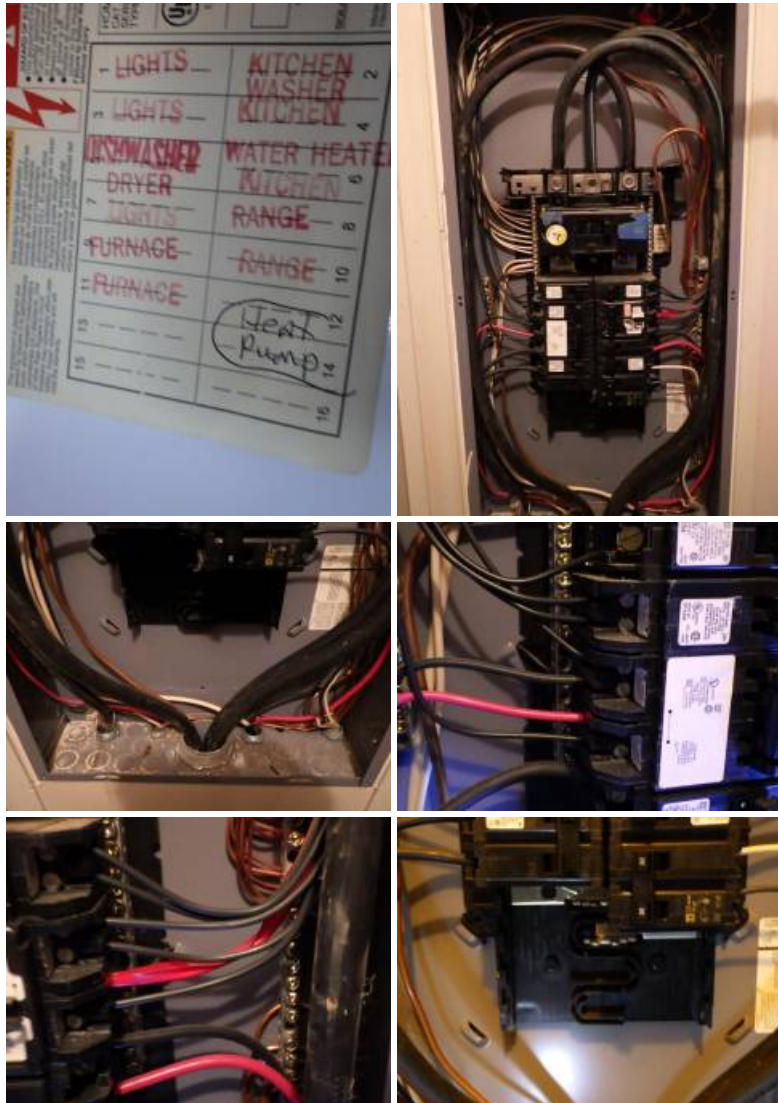
Distribution panel has been labeled , proper identification is not traced

Room for expansion/ additional circuits, Minimal room for expansion/additional circuits

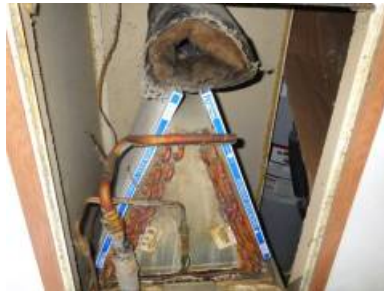
Unit was operational at the time of inspection.
Furnace is an older unit
recommend yearly servicing and maintenance by a qualified
service technician.

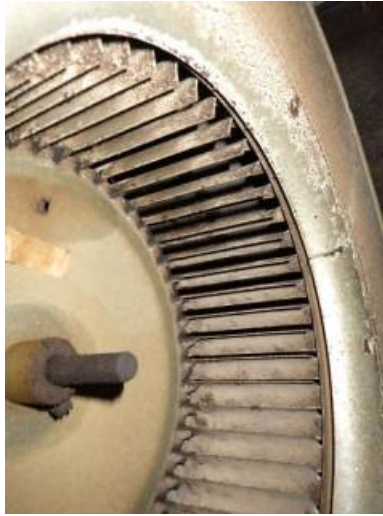
Pump / Blower Fan:

System lacks cleaning. Fan compartment is dirty.
Appears Serviceable.

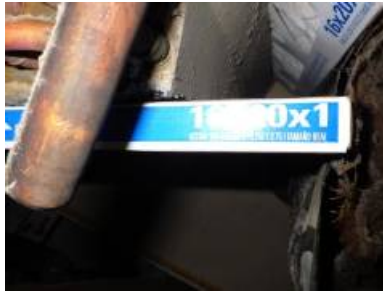
Air Filters:

Size of filters installed, 16 X 20 X 1

Satisfactory - The filter is clean and correctly installed. It is recommended that the filter(s) be changed or cleaned every 30 to 45 days for best performance..

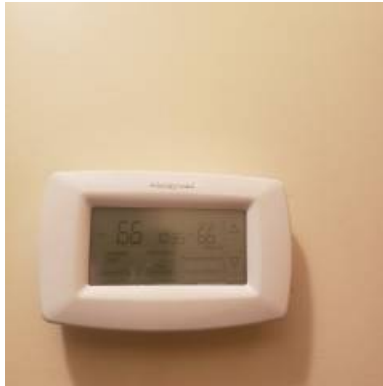
Normal Controls:

☒ ☐ ☐ ☐ Thermostat is located in the hallway.

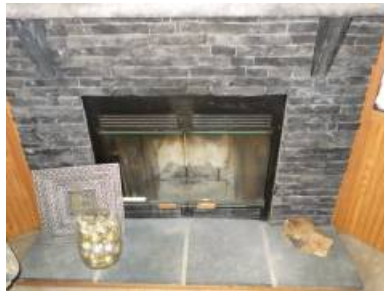
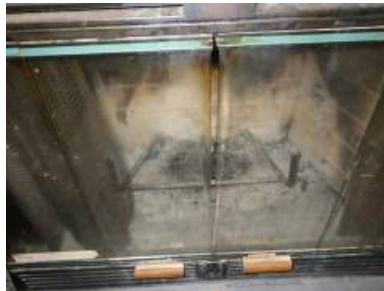
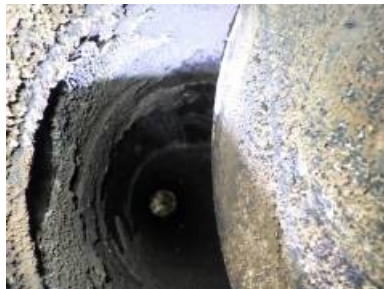
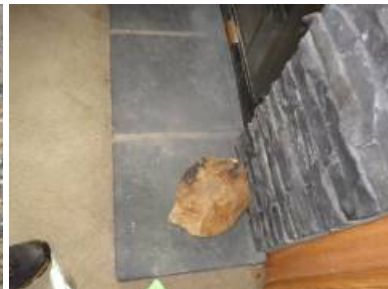
Fireplaces / Solid Fuel Heating:

Wood - The fireplace is designed to burn wood.

Creosote is a tar-like substance that is created by burning wood fuels. It often lines the upper part of the firebox and flue. If not removed can create a fire hazard

Cracked / Loose / Damaged fire brick noted

There is a mantel installed and it meets the 12 inch minimum clearance above the firebox

The Inspector noted missing carbon-monoxide detectors. A carbon-monoxide detector should be installed in the same room as the fireplace

Recommend cleaning before use

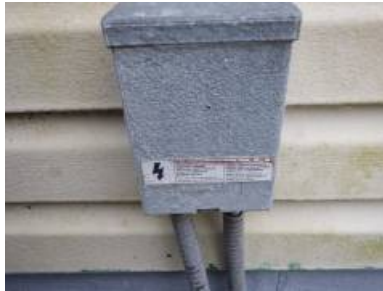
Conduit was noted to be broken/ detached from the breaker box and has wire exposed. - Recommend corrections as needed.

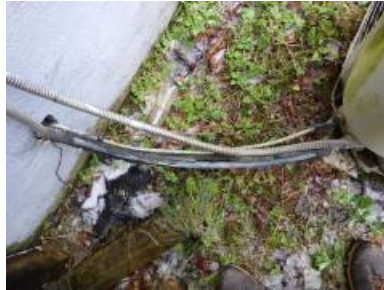
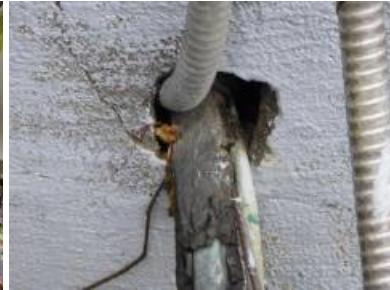
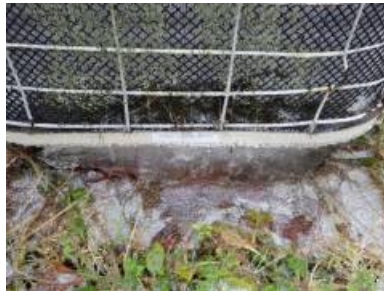
Some deterioration of cooling fins has occurred at the condenser coils outside.

Condenser unit is at or below grade: This can cause condenser deterioration; at least 3 to 6 inches is a good guideline to help prevent condenser deterioration.

Maintenance: Caulk around the A/C lines and any holes , gaps , or penetrations points to reduce the risk of moisture and pest intrusion.

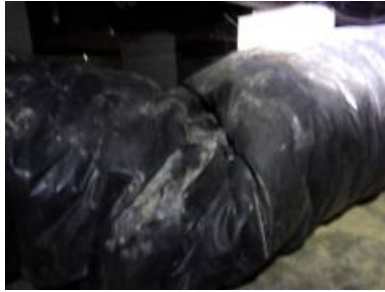
Ductwork / Distribution:

Damage/Deterioration noted

Crushed, crimped and/or excessive bends noted in ductwork.

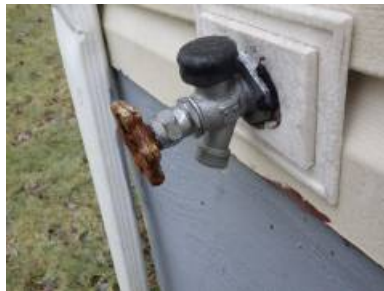
Hose-bib Style(s): Frost proof type

Defects / Concerns noted: Sample (s) inoperative.

Concern(s) / Recommendation(s) Recommend not leaving hoses attached during freezing weather as damage can occur .

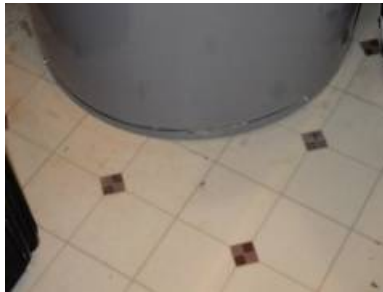
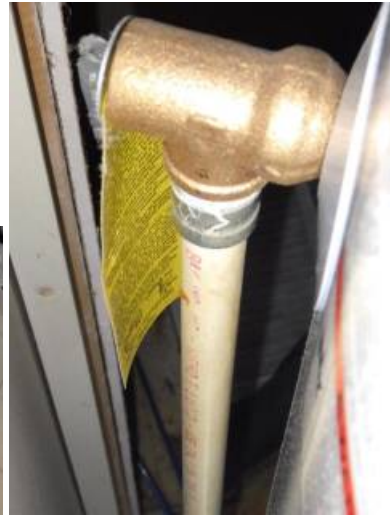
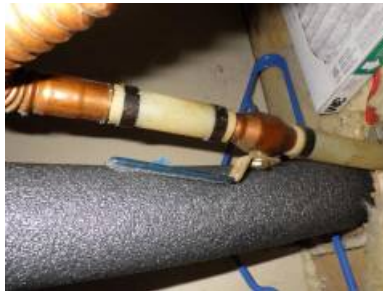
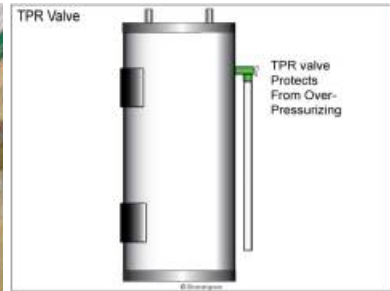
- ☐ ☐ ☒ ☐ Operational at the time of the inspection
 Damage/Defects noted
 TPR line discharges out of view. this is not recommended due to if there if a problem it can go undetected for quite some time , 6 inches above the floor is recommended
 The water heater is not equipped with a water leak pan , consider installing one , a pan under the tank is designed to prevent or minimize water damage from the tank should a leak arise

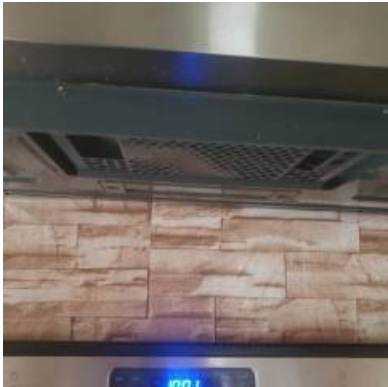
Ventilation:

<input checked="" type="checkbox"/>	<input type="checkbox"/>	<input type="checkbox"/>	<input type="checkbox"/>	Anti-Tip Installed, The oven was functional , but was neither calibrated nor tested for its performance.
<input type="checkbox"/>	<input type="checkbox"/>	<input checked="" type="checkbox"/>	<input type="checkbox"/>	Recirculation type, not vented to the outside. Light is inoperative.

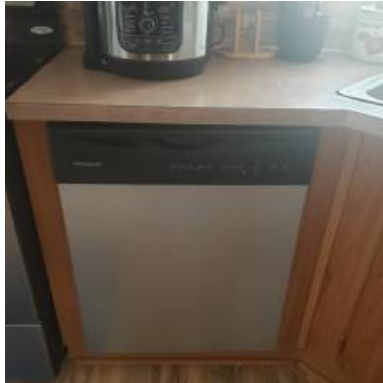
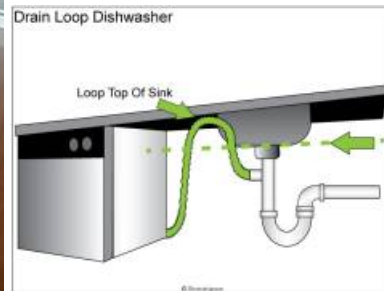
Dishwasher:

OK NI MM RR
☐ ☒ ☐ ☐ Appears in serviceable condition.
A proper air gap IS NOT installed in the dishwasher drain line.

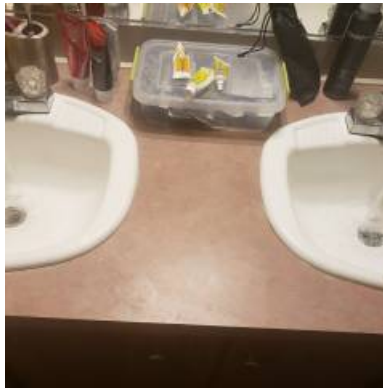
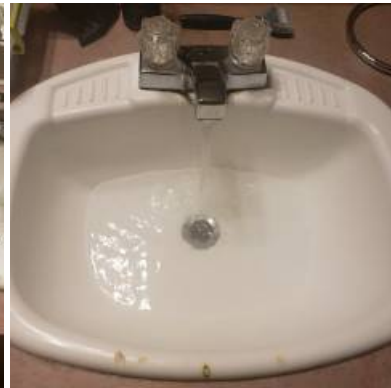
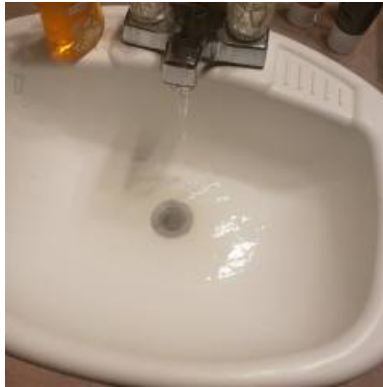
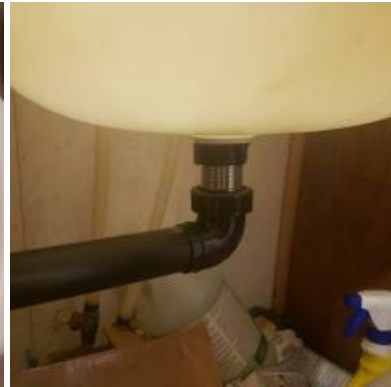
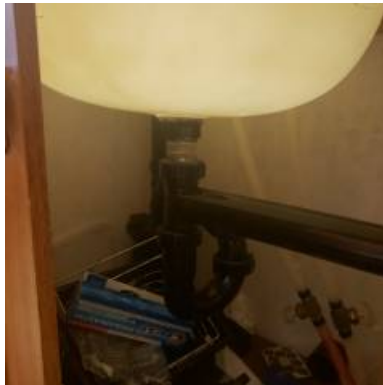
The following problems were noted at the drain:
Drainage is a bit slower than normal.

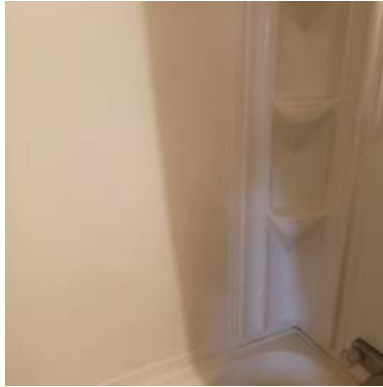
OK	NI	MM	RR	
Caulking/Water Contact Area	<input type="checkbox"/>	<input type="checkbox"/>	<input checked="" type="checkbox"/>	<input type="checkbox"/>	Attention Needed: The caulking in the water contact areas appears to need attention. Damage may result if not correct. Action Necessary- Some caulking in the water contact areas is necessary. There may be current damage. This inspection is of the visible areas only. No invasive action was necessary.
Bath Ventilation:	<input checked="" type="checkbox"/>	<input type="checkbox"/>	<input type="checkbox"/>	<input type="checkbox"/>	There is an exhaust fan installed in this bathroom, and it is functional.
Doors:	<input checked="" type="checkbox"/>	<input type="checkbox"/>	<input type="checkbox"/>	<input type="checkbox"/>	Hardware operational.

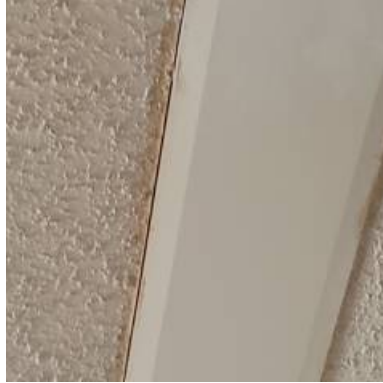
OK	NI	MM	RR	
Windows:	<input type="checkbox"/>	<input checked="" type="checkbox"/>	<input type="checkbox"/>	<input type="checkbox"/>	Unable to verify functionality of windows due to personal belongings blocking access.
Walls:	<input checked="" type="checkbox"/>	<input type="checkbox"/>	<input type="checkbox"/>	<input type="checkbox"/>	Appears to be in good condition at time of inspection.
Ceilings:	<input type="checkbox"/>	<input type="checkbox"/>	<input checked="" type="checkbox"/>	<input type="checkbox"/>	There is evidence of an unrepaired stain on the ceiling caused by a prior moisture leak.

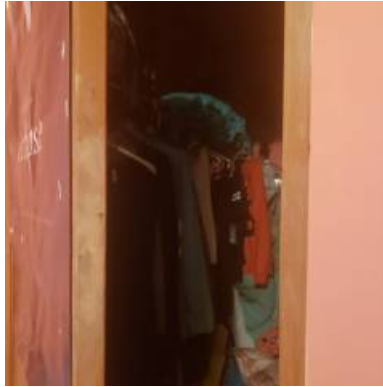
OK	NI	MM	RR	
<input checked="" type="checkbox"/>	<input type="checkbox"/>	<input type="checkbox"/>	<input type="checkbox"/>	Appears serviceable.
<input type="checkbox"/>	<input type="checkbox"/>	<input checked="" type="checkbox"/>	<input type="checkbox"/>	Missing outlet cover noted.

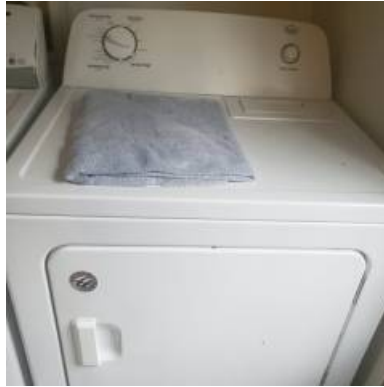
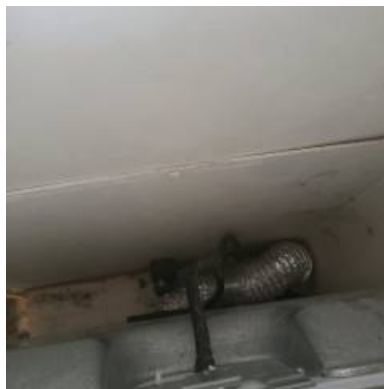
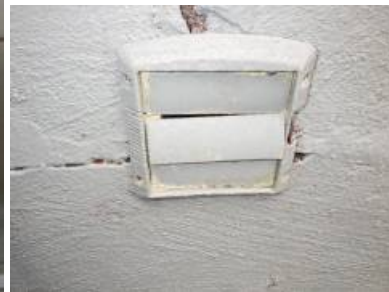
Dryer Vent:

A dryer vent is provided, but does not vent to the exterior. The dryer vents into the crawlspace. This is not an acceptable practice. It introduces excessive moisture and lint into the crawlspace area.

When properly vented to the exterior the vent is too close to the AC unit- It empties at a location that causes the air conditioning condenser cabinet to collect the lint. This reduces the efficiency of the air conditioning system, and it could result in system failure. - Recommend routing the vent to another location.

Dryer Vent piping is torn / disconnected and needs repair / replaced for proper operation

Missing / Broken baffles noted on the exterior vent- Recommend Replacing exterior vent

The dryer vent system should be cleaned and serviced regularly for safety.

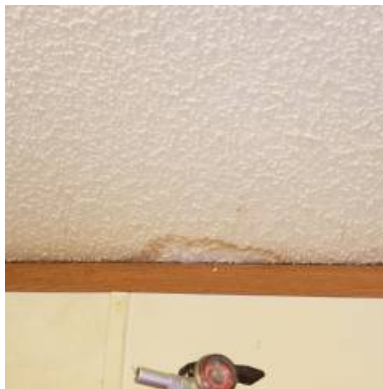
OK	NI	MM	RR	
<input checked="" type="checkbox"/>	<input type="checkbox"/>	<input type="checkbox"/>	<input type="checkbox"/>	Appears serviceable.
<input checked="" type="checkbox"/>	<input type="checkbox"/>	<input type="checkbox"/>	<input type="checkbox"/>	220 Service- Appears operational.
<input checked="" type="checkbox"/>	<input type="checkbox"/>	<input type="checkbox"/>	<input type="checkbox"/>	Appears to be in good condition.
<input type="checkbox"/>	<input type="checkbox"/>	<input checked="" type="checkbox"/>	<input type="checkbox"/>	Previous Leak - There are signs of a previous water leak in the ceiling in this room. It does not appear to be an active leak.
